Geological Survey of India

**A note on preliminary assessment of landslides in Gudalur Taluk
Nilgiri District, Tamil Nadu**

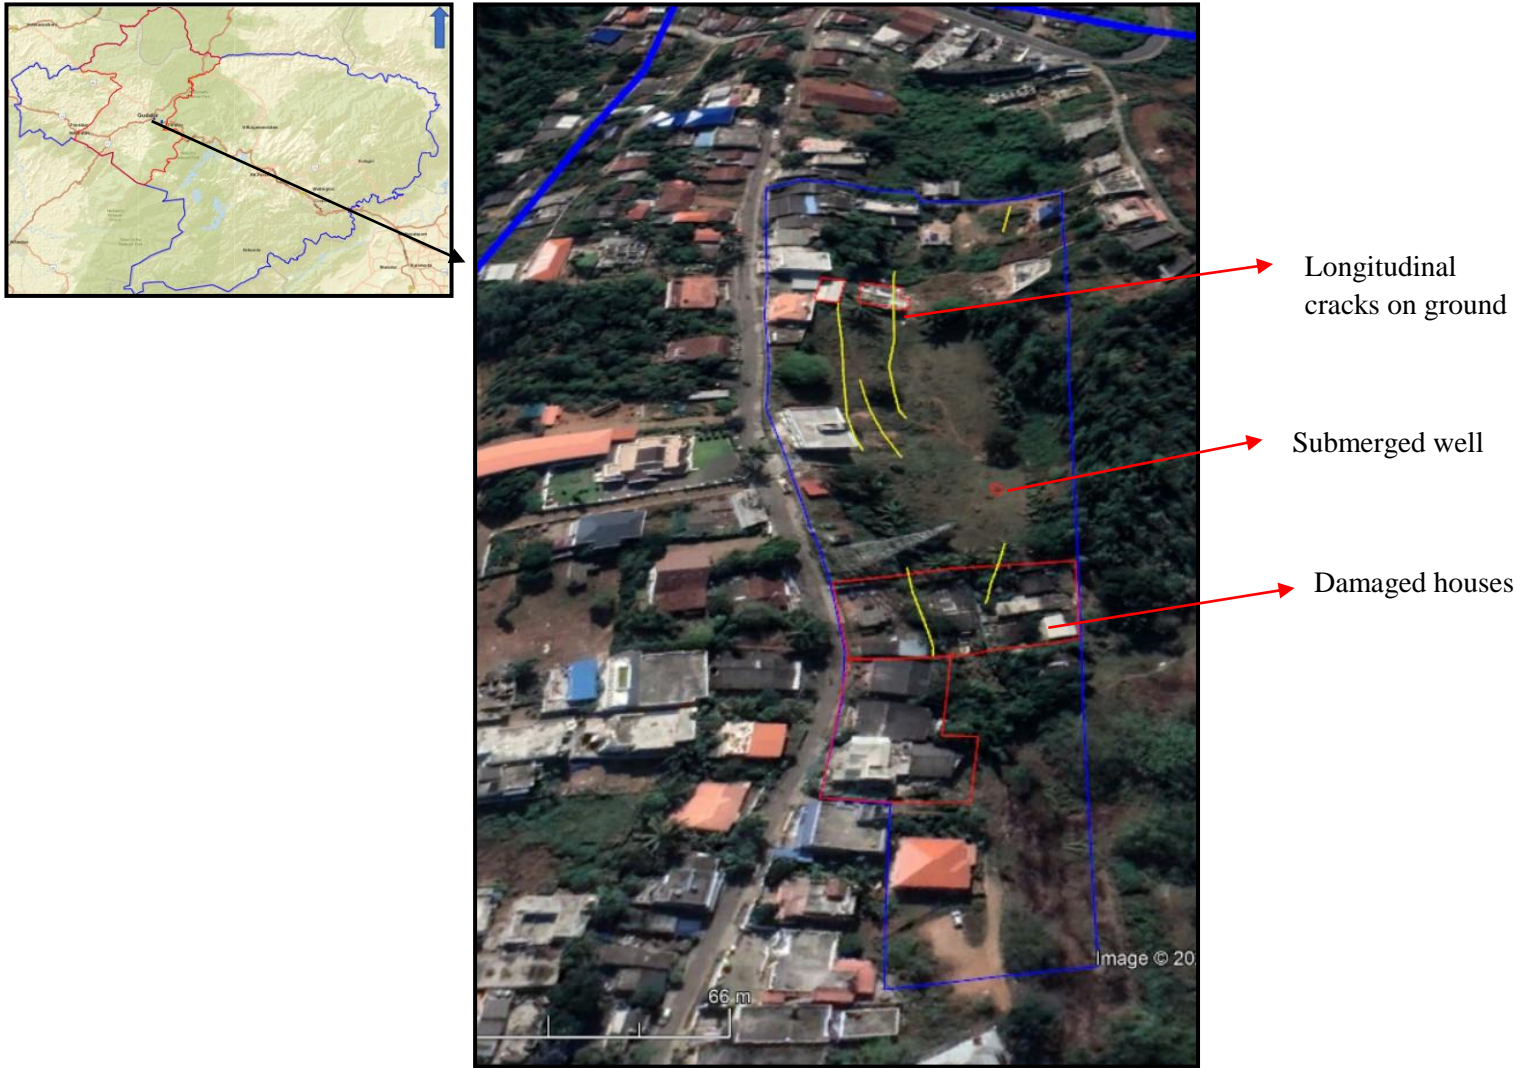
The slide is a complex type of slide, which initiated as cut slope failure, slope modification and anthropogenic activities which is subsequently leading to the subsidence and creep. Ground cracks ranging from 5-15 cm were observed in the close vicinity of the slide, which are indications of chances of future reactivation, if untreated. Ground subsidence of about 1 m was observed in the slide zone. The slope forming material is mainly soil/ dump debris materials having a thickness of about 2-3 m in (Fig.2). Deep gully erosion along the streamlet due to heavy rainfall. Presence of dumped debris materials along the slope, which is very prone to cause landslides. Steep cutting of slope for building constructions also supplement to the cause of the slide.

Fig: 2. Plain view of study area showing landslide location area showing cracks

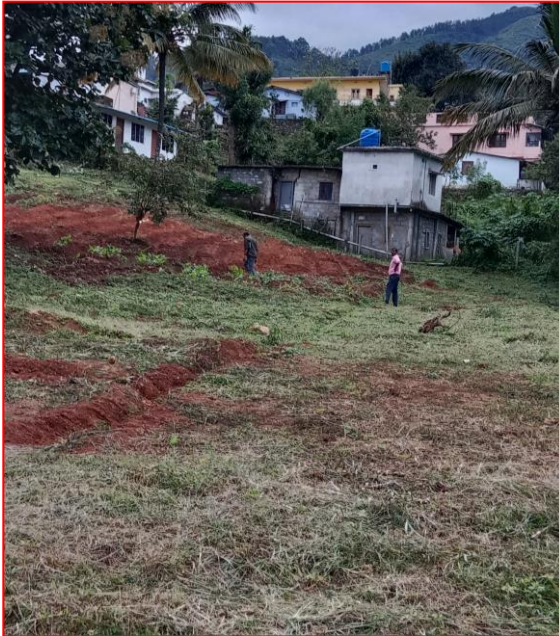
Fig: 3. Land has been affected by long longitudinal cracks and gully erosion

However temporary supportive measures should be implemented at the earliest as given below

- i) Proper channelizing of the streamlet and diverting it to the stable area.
- ii) People living in the damaged houses, in the unstable slopes/ subsided area may be relocated in safe places at their convinience.

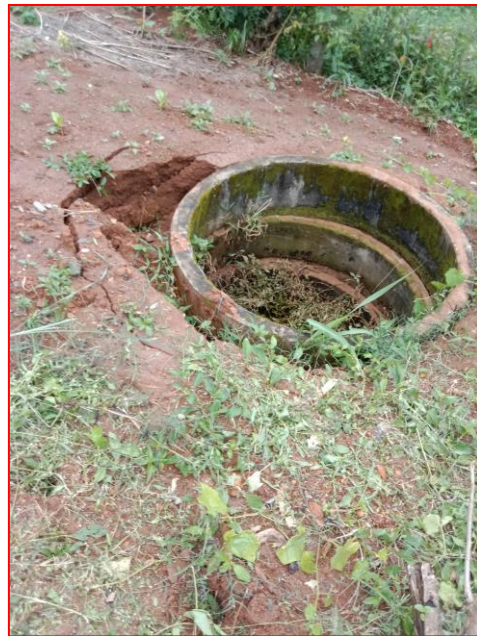
Fig.4: Well got submerged due to subsidence and creep

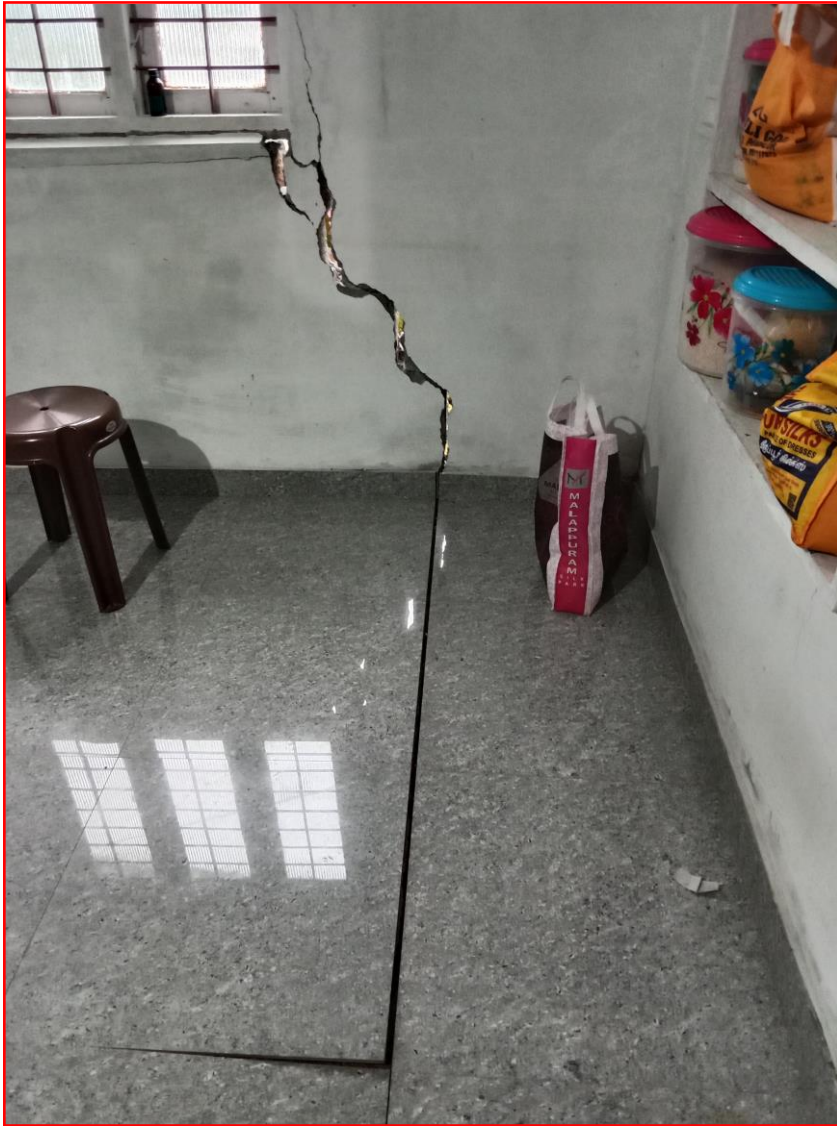
Fig.5: Crack in Wall and floor

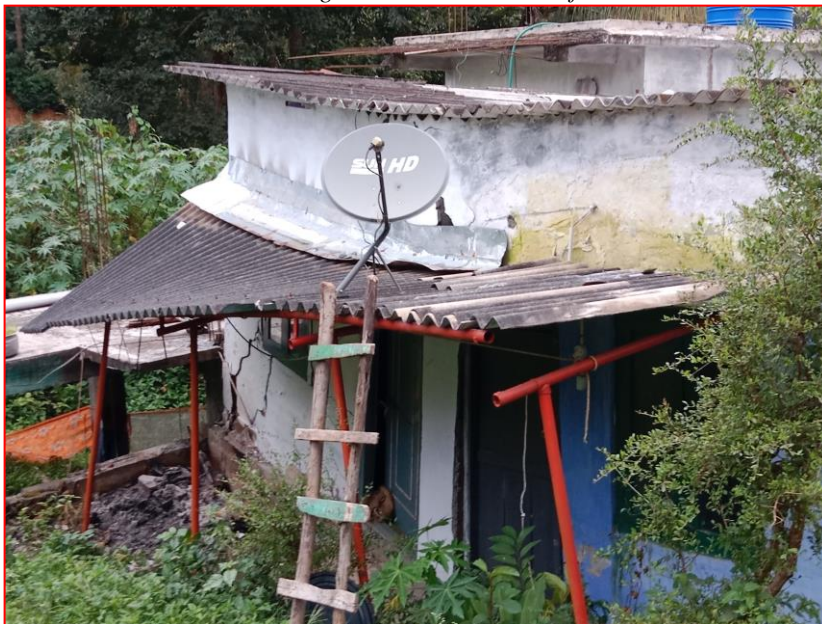
Fig.6: House got completely damaged due to subsidence and creeping

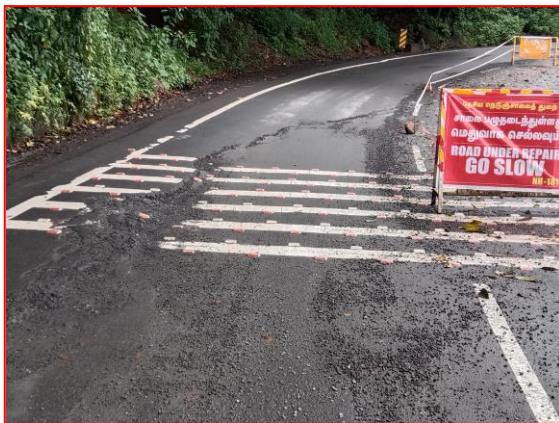
Landslide subsidence and the road got partially damaged in NH 181 near Gudalur taluk. Rainwater ingress over a prolonged period and blockage of drainage channel were caused road crack and subsidence. No proper management of efficient drainage outlet system designed and storm water drainages system needed at road side of NH-181 near Gudalur. During high intensity of rainfall in prolonged duration which leads to oversaturation in turn pore pressure development over the crown surface.

Fig.8: Subsidence of NH 181 road near Nadu Gudalur

1. As a temporary measure regularization of traffic along the damaged road and no heavy trucks should be allowed to pass through.
2. To prevent water percolating along the current fractures, remove the slush materials from each side of the road and fill it with rich concrete.
3. To prevent erosion and water stagnation, toe drains along the road become necessary for draining seepage water.

4. In case of heavy rains during the monsoon, proper care should be given to the existing culverts and drains to prevent choking and maintain free flow.
5. Avoid blocking, chocking, or diversion of the existing drainage system
6. Permanent remedial measures will be suggested once after compilation of detail geological site specific studies that would be carried out by GSI after necessary approval.

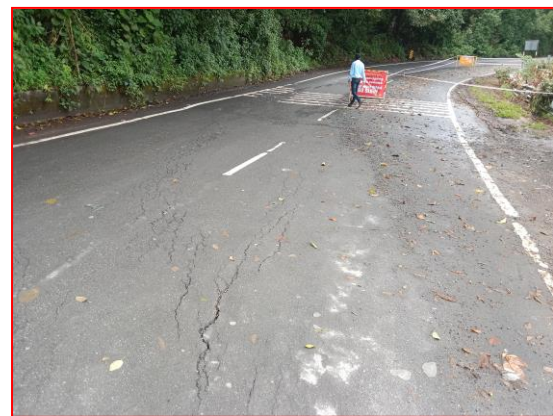
Fig 9: Subsidence with curvilinear cracks of NH181 road near Nadu Gudalur
