**A NOTE ON PRELIMINARY POST-DISASTER STUDY OF GROUND CRACKS  
AND SUBSIDENCE IN LINDOOR VILLAGE, LAHAUL AND SPITI DISTRICT,  
HIMACHAL PRADESH**

Christy Tom, Geologist and Siddhartha Jang Thapa, Geologist  
Geological Survey of India, Northern Region

दिसंबर/ December, 2023

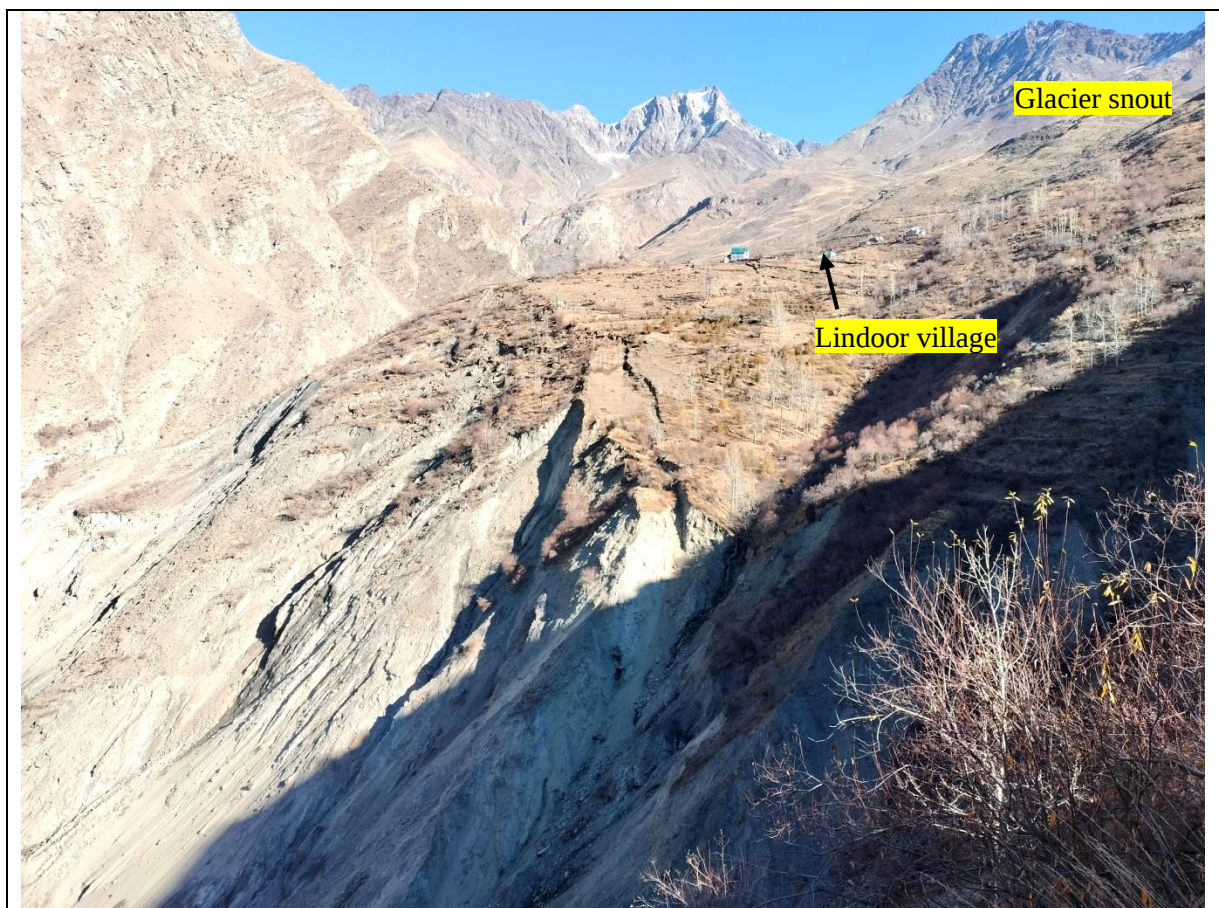
Fig. 5: Active slide (slide 1) seen during the time of visit which is ~ 130 m from Lindoor village.

- 04) It must be noted that although the slumped debris mass near the toe of slide 1 and 2, is acting as a toe support for the failure, continuous pace of even smaller failures may induce instability to this mass with further scope of getting the same flown away by Jahlma *nala*. Therefore, it would be better if proper toe supports to this mass, as well as all along the debris/talus failure cone may be provided. This in turn, would prevent pressure of slush charged with water coming from Jhunda every year, especially in case of incessant rainfall spells/flash flood events during monsoon.

- 05) Appropriately designed retention structures/walls with stacks of crate walls may be provided all along the slumped mass along the left bank of Jahlma *nala* to retain the debris materials from further slipping.

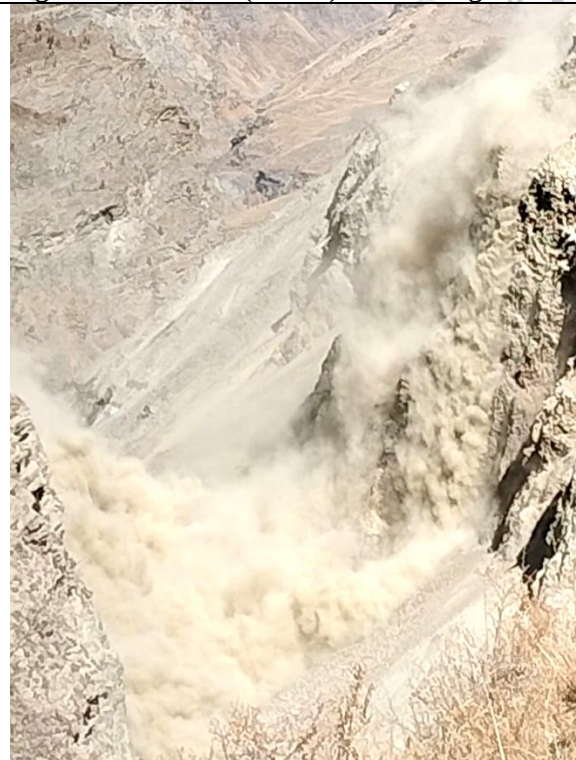
Fig. 6: Active slide (slide 2) with debris fall seen during the time of visit along the NNE-SSW trending Jahlma *nala*.

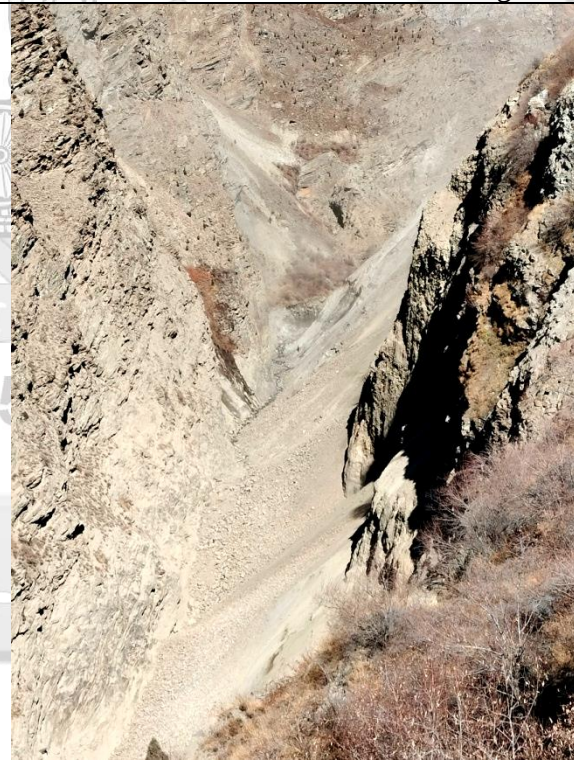
Fig. 7: Continuous water seepage observed along the slope towards the left bank of Jahlma *nala* where slide 2 is active.

- 06) Water seepage is the major problem in the area. Therefore, controlled channelling/piping of surface waters using appropriately designed water supply network instead of open *nalas*/channels for local use/irrigation would limit the over saturation of soil.

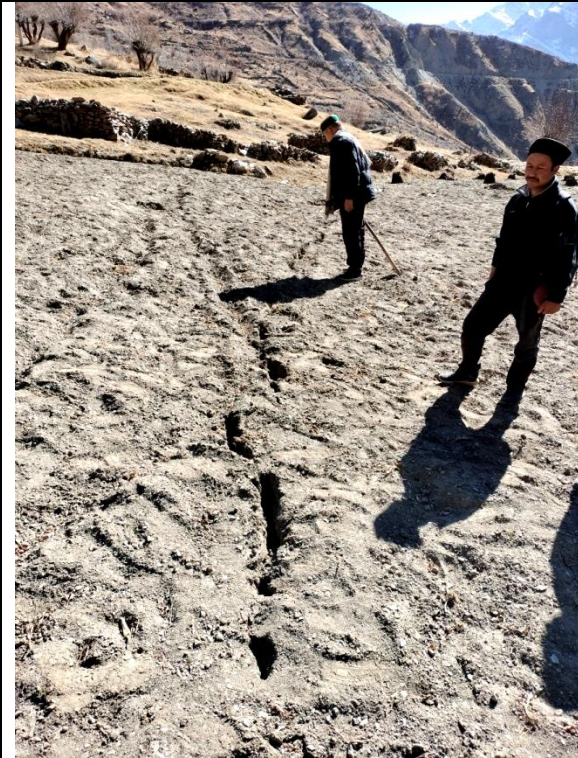
Fig. 8: NNE-SSW trending transverse cracks observed in agricultural fields near the periphery of the active slide 2.

02) Temporary solutions are sealing of cracks by impervious material to avoid further enlarging/ ingress of water in debris/talus material at the earliest. Subsequently, crude monitoring/ vigil is a must in the affected and adjoining area regarding reoccurrence (after filling up of existing crack/subsidence affected area) or fresh occurrence of such incidences.

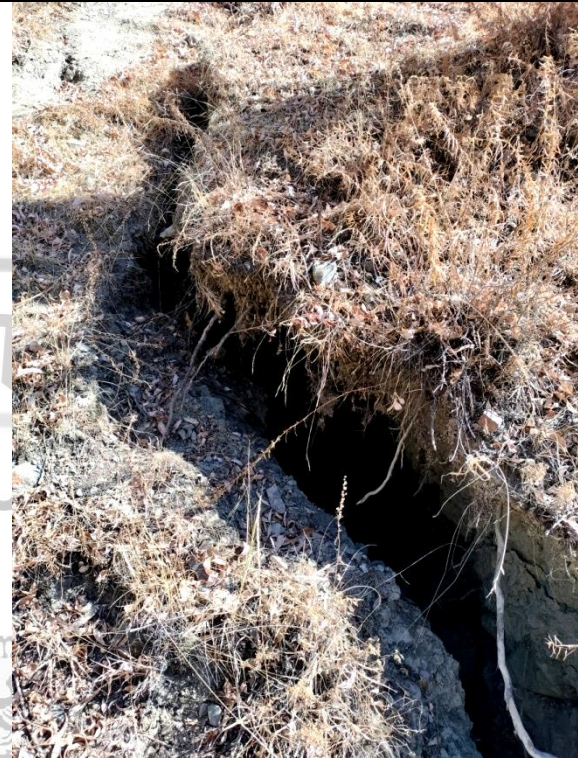
Fig. 9: Vertical displacement seen in the NNE-SSW trending transverse cracks indicating subsidence of land near the crack zone.

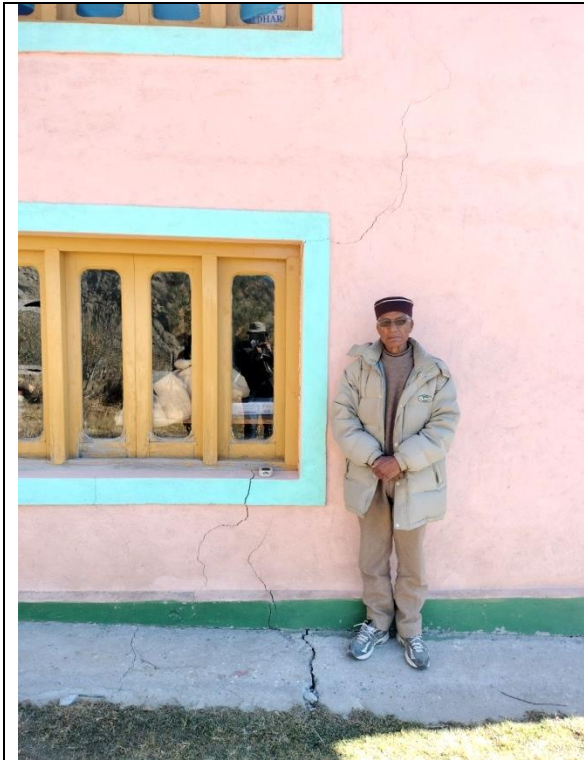
Fig. 10: Ground cracks continuing as diagonal cracks into the walls of a house.

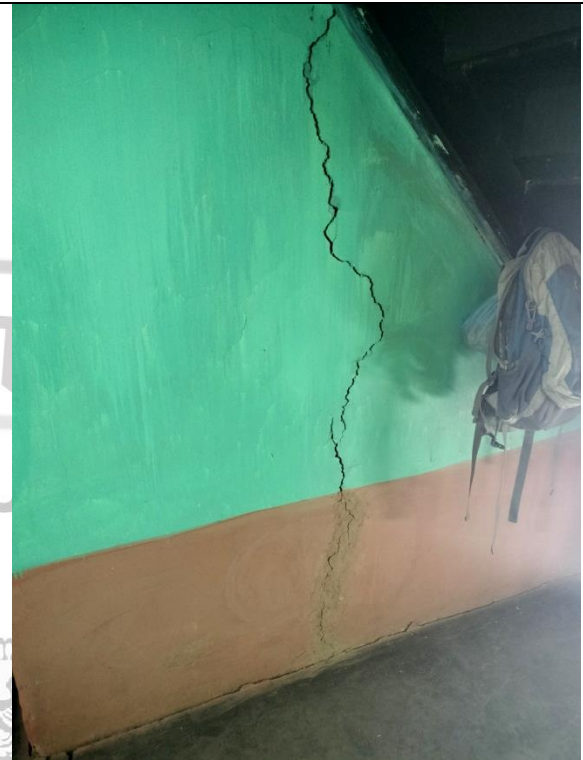
Fig. 11: Horizontal and vertical cracks observed in a house with mud plastering.

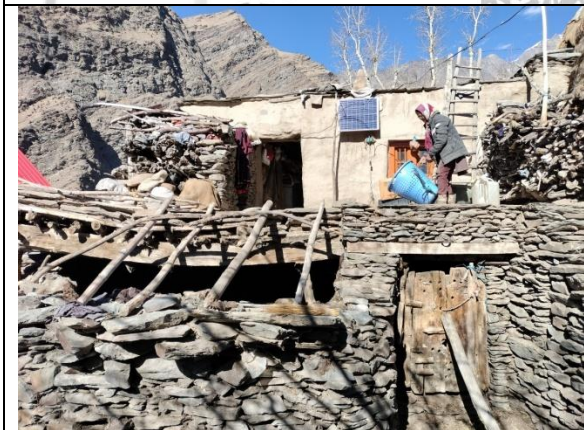
Fig. 12: 80 year old highly damaged mud house built on rock piles with no proper foundation.

The houses which have suffered structural damage and the houses located adjacent to enlarging crown and widening portions of the landslides and located down slope of glacial snout should be shifted to safer locations. The rehabilitation of such houses to a safer place may be considered by the local stakeholders and the District Administration, with the initiative coming from the disaster management authorities of the state, taking into account the aforementioned criteria.

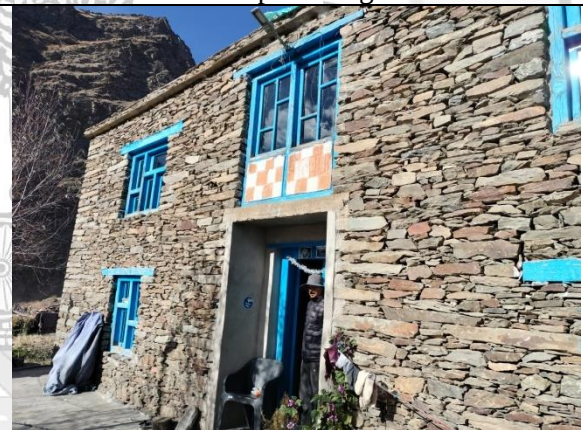
Fig. 13: Two storeyed house made up of local rocks and mud as cementing materials.

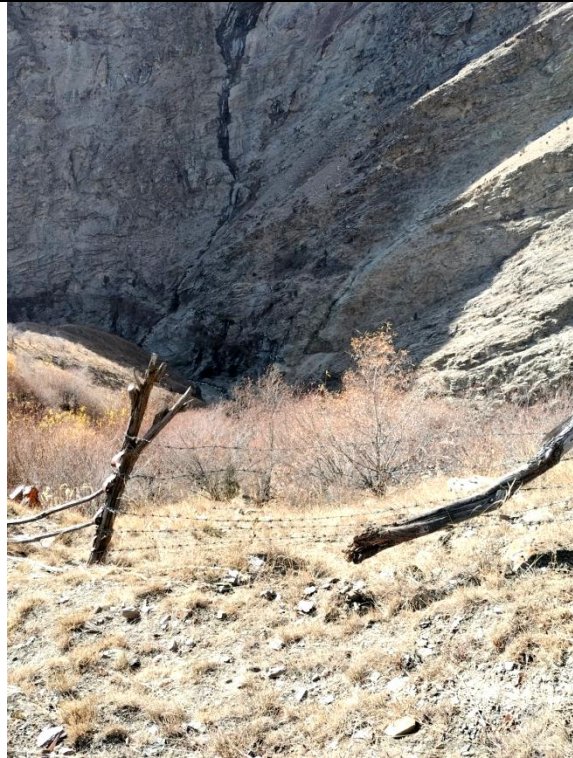
Fig. 14: Offsetting of fences seen near the crown portion of active slide 2.

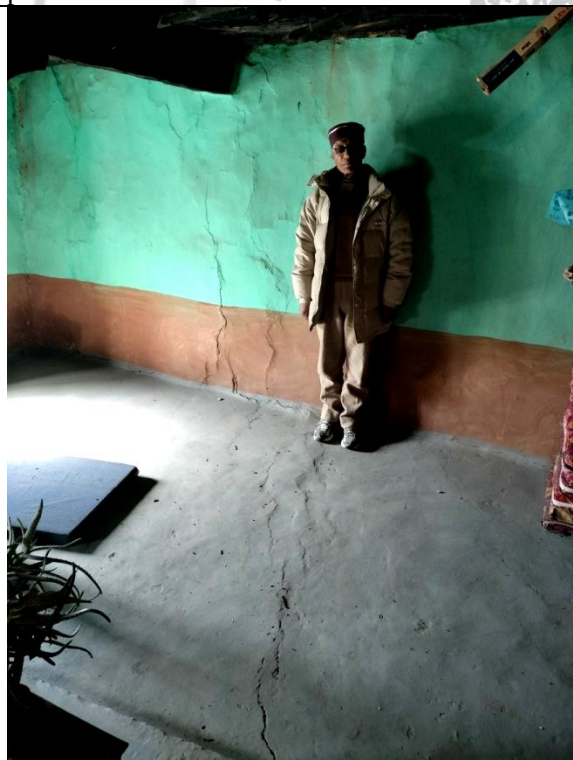
Fig. 16: Cracks on the floor of a mud house can be seen continuing towards the wall.

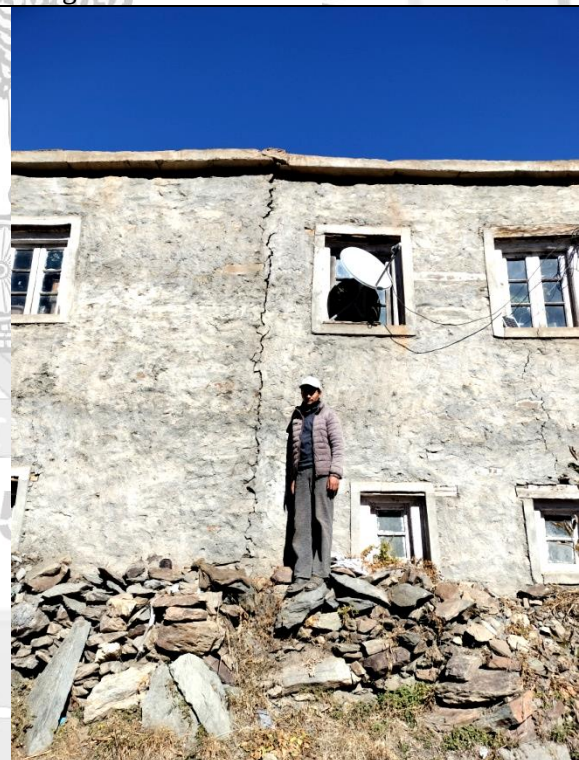
Fig. 17: Subsidence near the house has led to the formation of irregular vertical cracks.

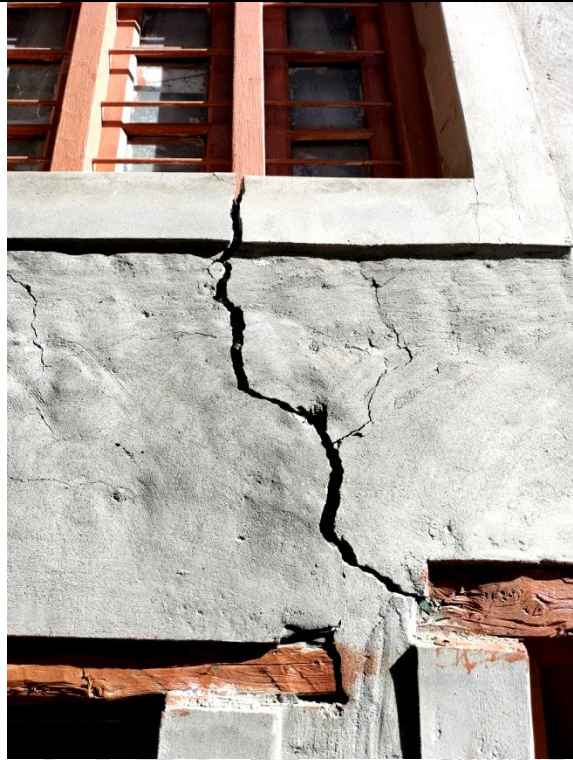
Fig. 18: Step cracks with 2.6 cm opening seen in a mud house.

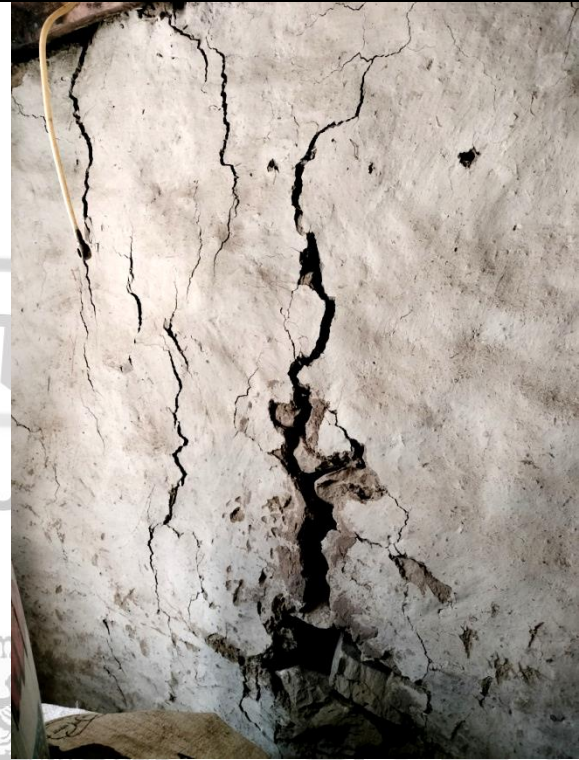
Fig. 19: Highly damaged and bulged wall of an old mud house (~80 years old).

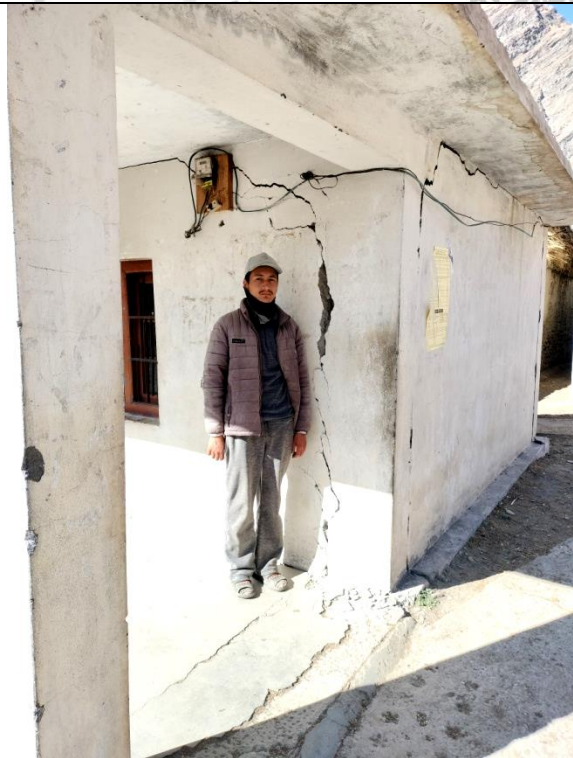
Fig. 20: Ground cracks continuing into the walls of a community centre. Note that the trend of cracks on the wall and ground is same.

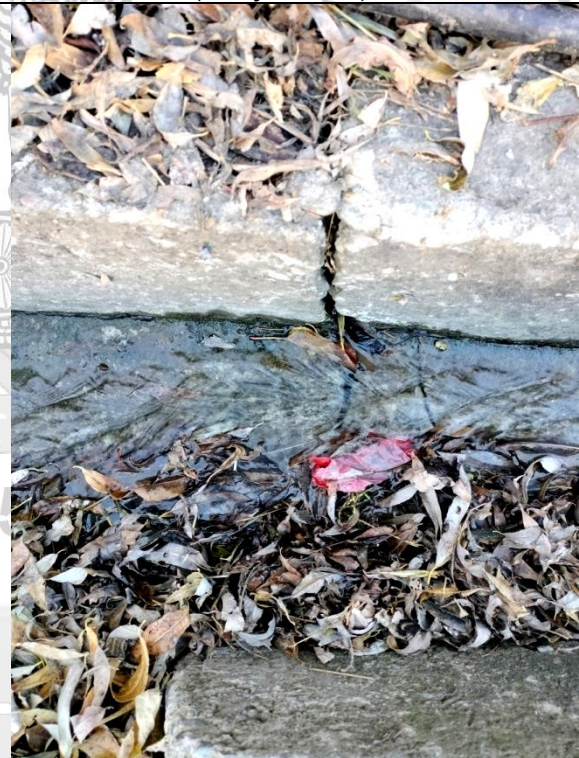
Fig. 21: Vertical cracks observed in a man-made channel with flowing water near a house leading to possible seepage of water to the ground.

Further, it was found during the visit that many non-concrete and concrete *nala* (Figure 21) are passing through the vicinity of houses in the village; these *nalas* have flowing water which again in turn leads to water seepages directly or through cracks near the house. Many houses in the village are as old as ~80 years, one or two storied and are made up of local rocks and mud plastering with no proper foundation, and any instability in slope due to water seepage can cause these structures to collapse very quickly. Incidences of wall collapses in some mud houses have also been intimated to authors during their visit by the villagers. As per information received from villagers there was continuous blasting of rocks for laying down water pipes during the month of October 2023, on the right banks of Jahlma *nala* near to the location of active slides. This blasting activity further increased the damages to the houses.

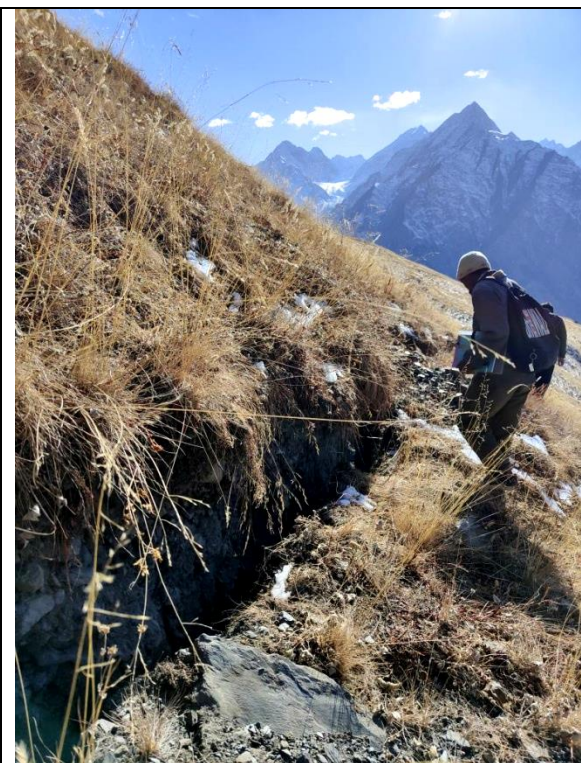
Fig. 22: Vertical displacement of ground and cracks observed near the glacier mouth towards the upper reaches of the area.

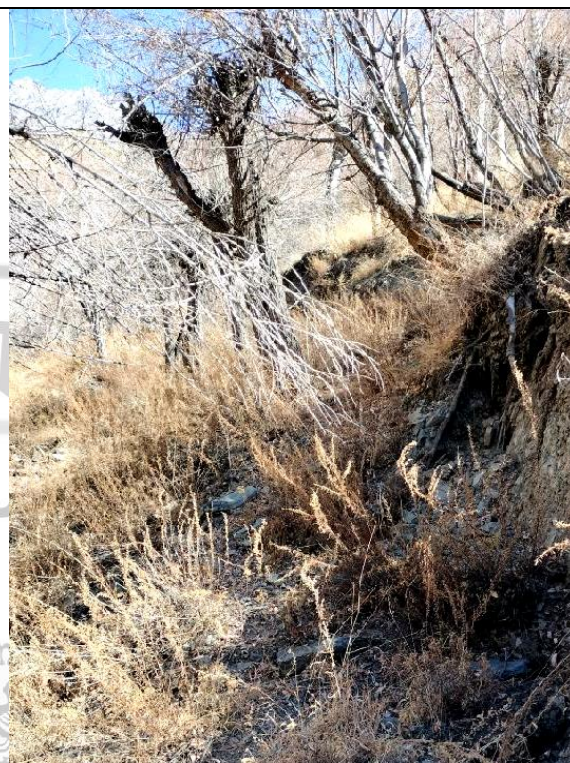
Fig. 23: Ground subsidence together with tilting of trees observed above the crown portion of active slide 1.

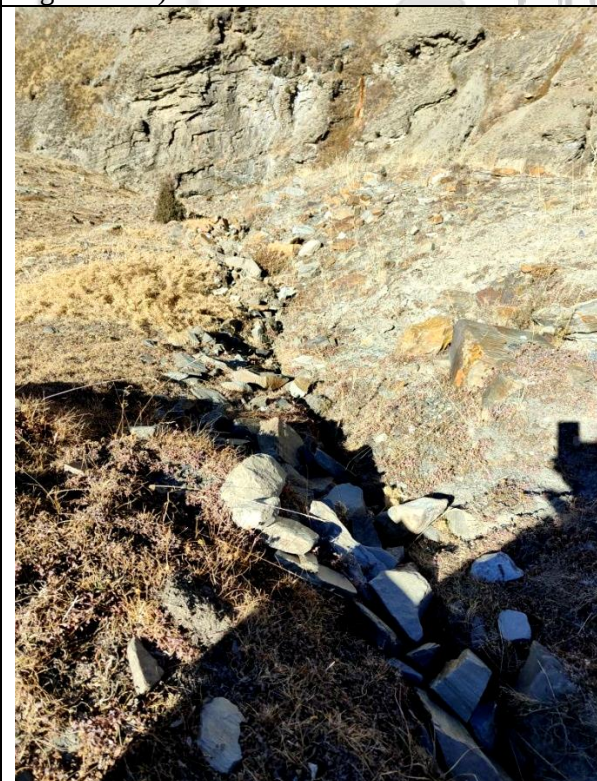
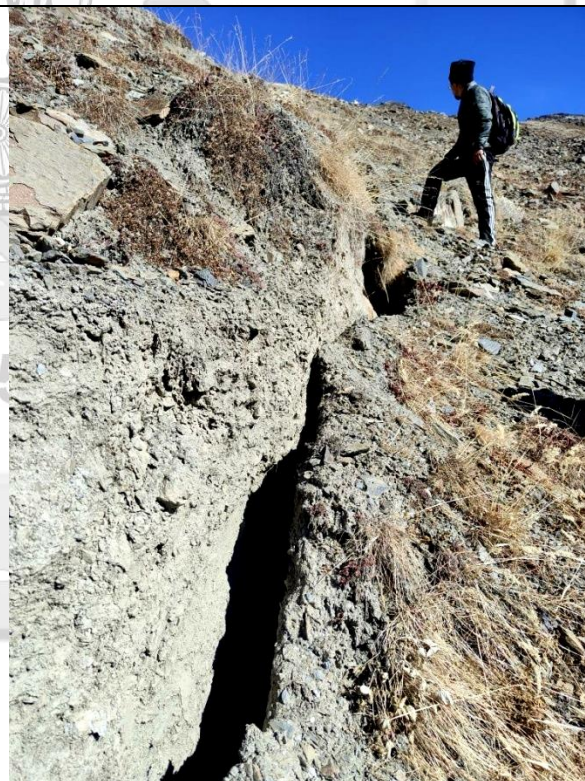
Some field photographs taken during field traverse surrounding the Lindoor village showing the major crack present in the area reaching up to the glacier present NE of Lindoor village (can be observed in Figure no. 4).

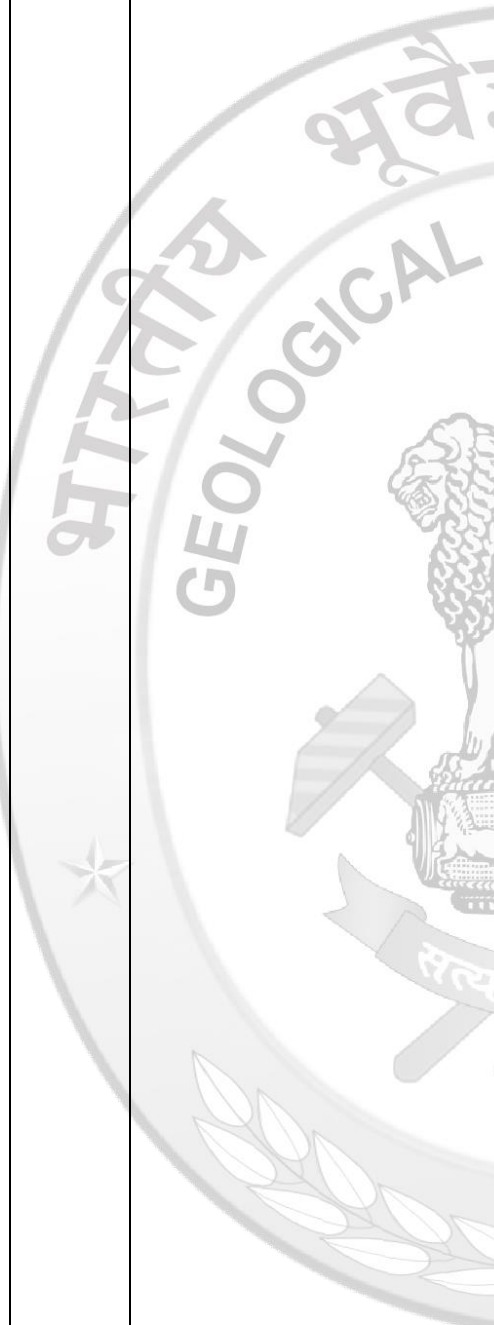
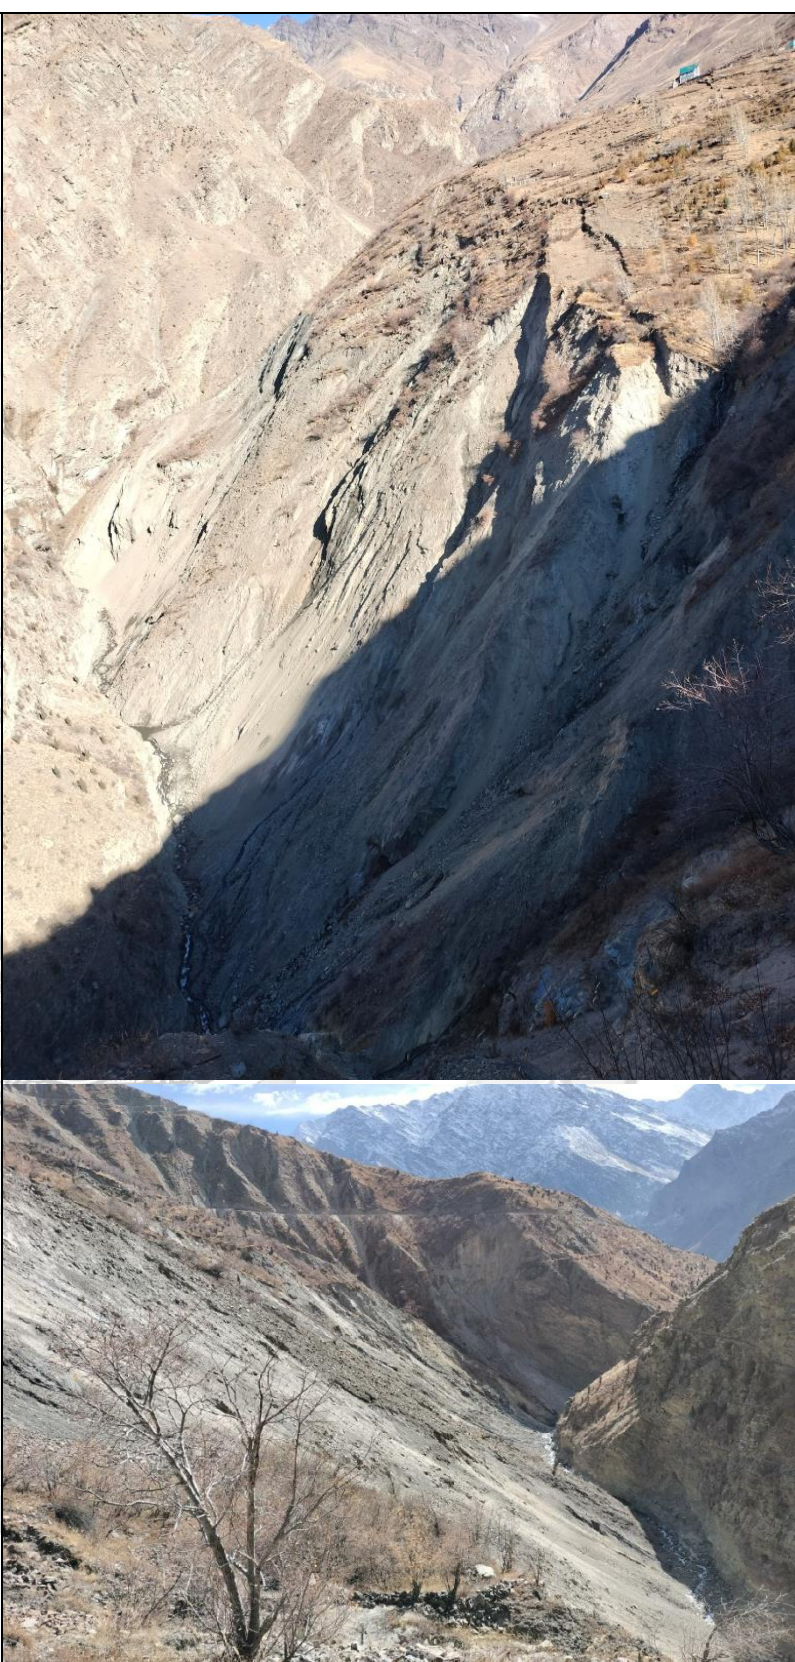
| 39 | <p>Photos. Sketch of Plan &amp; section of the slide</p> | <p>Fig.1 &amp; 2: Distal view from right and left side of Lindoor Debris/Talus Slide 1, Lahaul &amp; Spiti District.</p> |

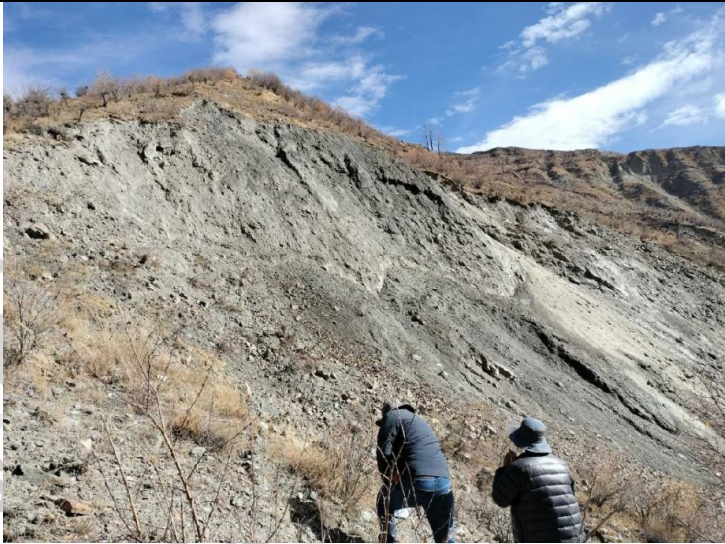
| | | <p>Fig.3: Crown of the Lindoor Debris/Talus Slide 1, Lahaul &amp; Spiti District.</p> |

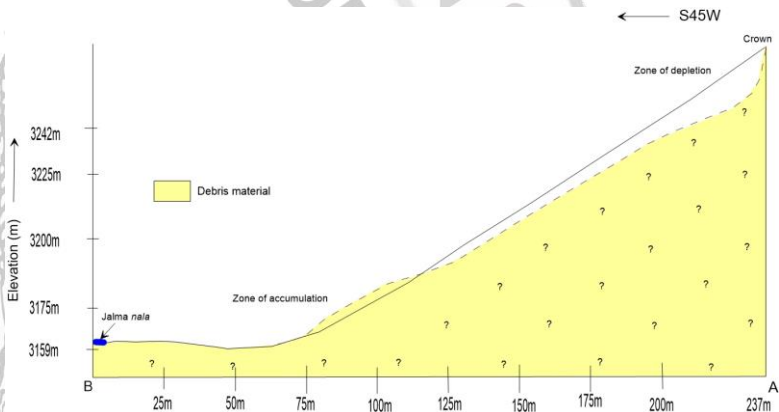
| No | Field | Description |
|---|---|---|
| 22 | Failure mechanism | Deep rotational failure |

| | | <p>Fig.4: Schematic cross-section of Lindoor Debris/Talus Slide 1, Lahaul &amp; Spiti District.</p> |

| 37 | Remedial measures | <ol style="list-style-type: none"> <li>1. Appropriately designed guide structures for toe support.</li> <li>2. Immediate filling/protection of reported tension/ground cracks as reported in agriculture fields towards upslopes of the slope failure and observed tension/ground cracks in Lindoor village area.</li> <li>3. Appropriately designed and placed checks along Jahlma <i>nala</i>.</li> </ol> |

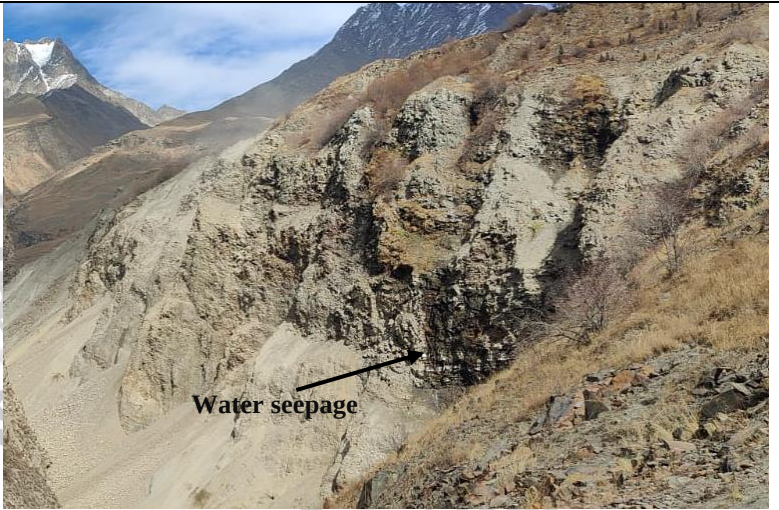
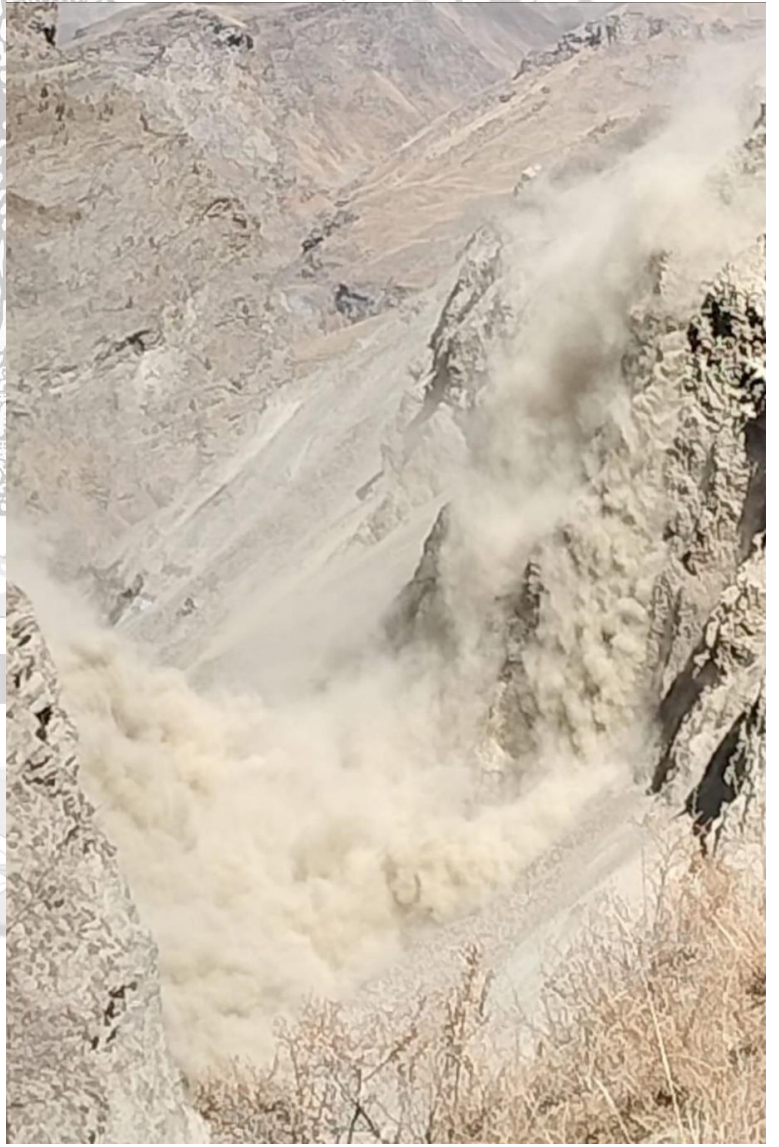
| 39 | Photos. Sketch of Plan & section of the slide | <p>Water seepage</p> <p>Fig.1: Distal view from right side of Lindoor Debris/Talus Slide 2, Lahaul &amp; Spiti District with seepage of water.</p> <p>Fig.2: Active slide and fall of debris/talus material.</p> |

| | | <p>Fig.3: Schematic cross-section of Lindoor Debris/Talus Slide 2, Lahaul &amp; Spiti District with seepage of water.</p> |

| 37 | Remedial measures | <ol style="list-style-type: none"> <li>1. Appropriately designed guide structures for toe support.</li> <li>2. Immediate filling/protection of reported tension/ground cracks as reported in agriculture fields towards upslopes of the slope failure and observed tension/ground cracks in Lindoor village area.</li> <li>3. Appropriately designed and placed checks along Jahlma <i>nala</i>.</li> </ol> |
