**A NOTE ON PRELIMINARY POST-DISASTER STUDY OF GROUND CRACKS  
AND SUBSIDENCE IN LINDOOR VILLAGE, LAHAUL AND SPITI DISTRICT,  
HIMACHAL PRADESH**

Christy Tom, Geologist and Siddhartha Jang Thapa, Geologist  
Geological Survey of India, Northern Region

दिसंबर/ December, 2023

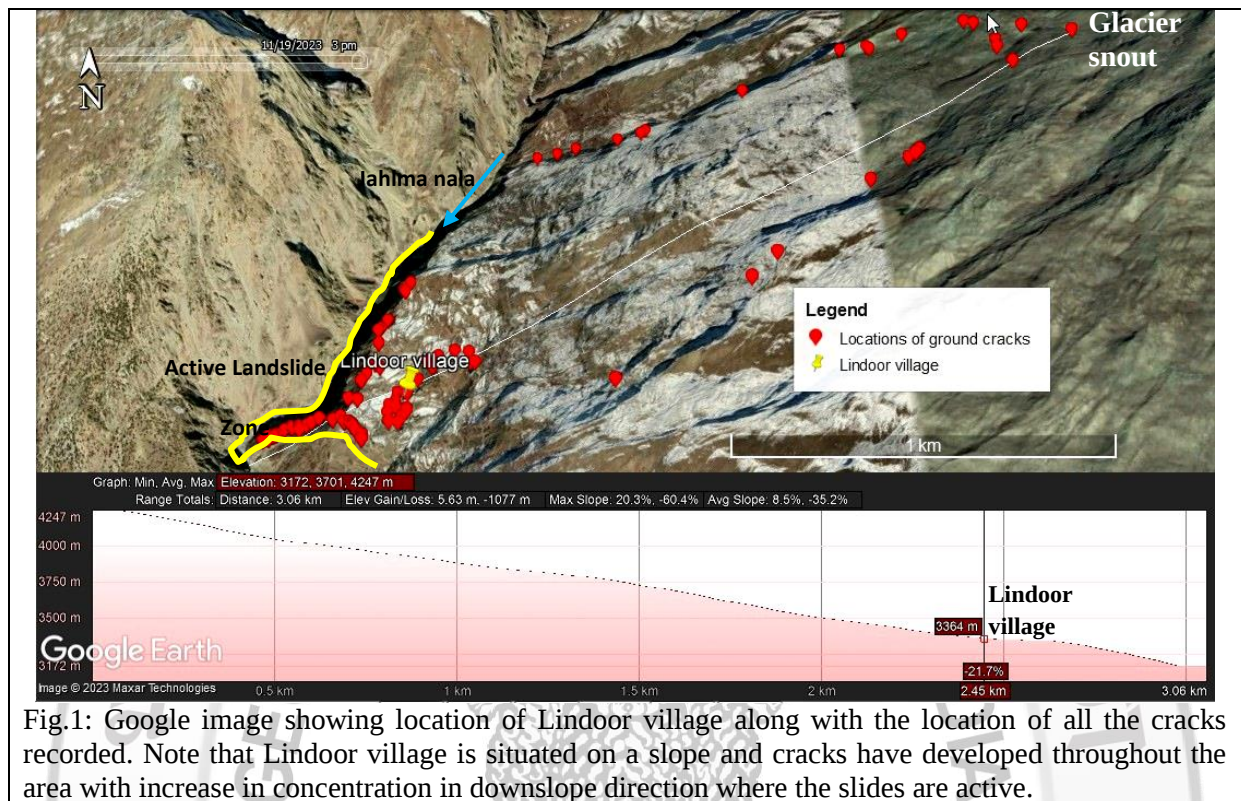
Fig.1: Google image showing location of Lindoor village along with the location of all the cracks recorded. Note that Lindoor village is situated on a slope and cracks have developed throughout the area with increase in concentration in downslope direction where the slides are active.

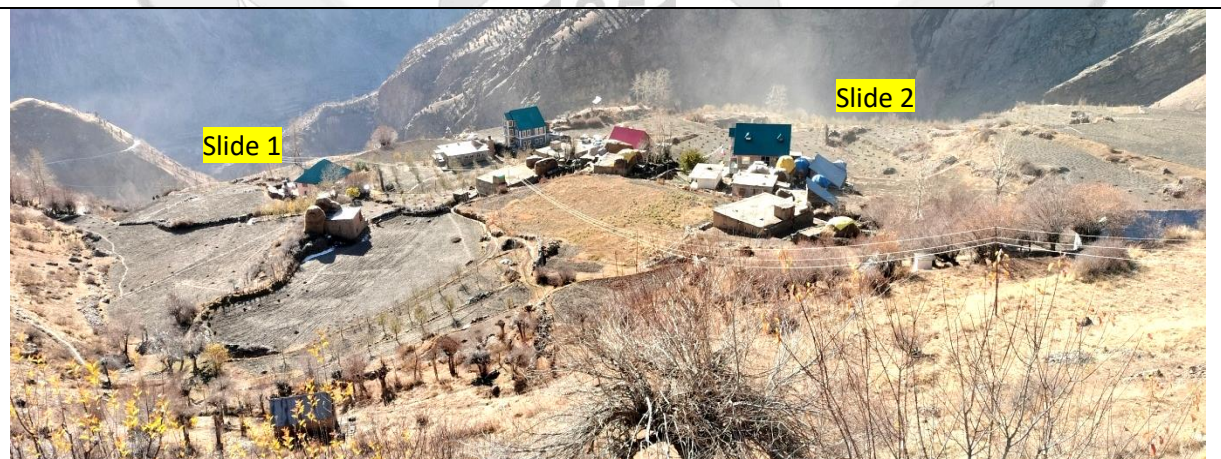
Fig. 3: Panoramic view of Lindoor village, Lahaul and Spiti district, H.P.

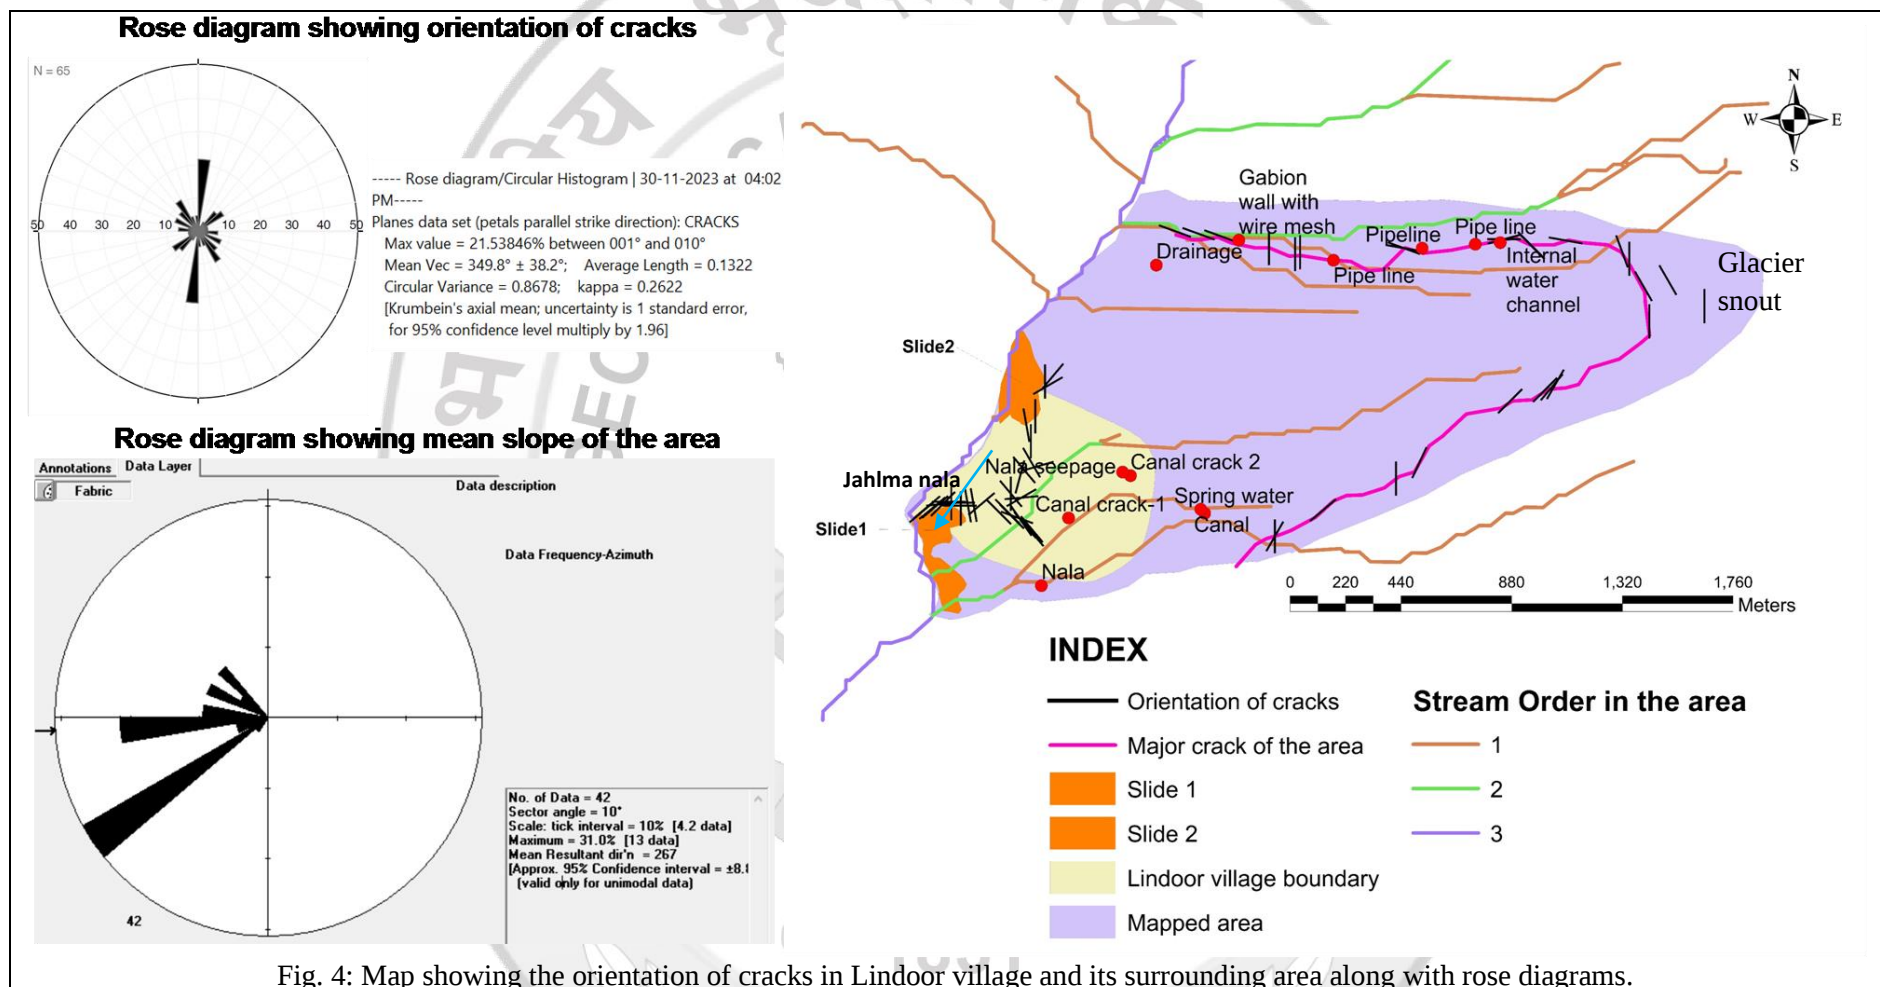
The slope along the Jahlma *nala* is steep with mean resultant direction of N267° (SW) and two active slides (Slide 1 and 2) were observed during the time of visit where the SSW flowing Jahlma *nala* is taking a SE shift in its course (Figure 4). Loose materials were continuously sliding along these slopes at the time of visit (Figure 6). Majority of the cracks both transverse and longitudinal (Figure 8, 9 and 22), observed in the area are concentrated near to the active slides indicate the retrogressive and widening nature of the slide. The general trend of the transverse cracks as per field data collected is NNE-SSW which is also following the general trend of Jahlma *nala* (Figure 4). Several parallel sets of ground cracks have been recorded up slope from the active slide zones towards the glacier snout which are having similar trend with the ground cracks observed near the active slide zones (Figure 4 and 22).

Fig. 4: Map showing the orientation of cracks in Lindoor village and its surrounding area along with rose diagrams.

After tracing the major crack (Figure 4) in the surrounding village area- developed during the year 2023, as per interactions with the villagers- it may be inferred that the whole mapped area falls under the same prominent slope/facet and the major crack can be correlated with the other cracks observed within the village premises (Figure 4). It was also observed that the major crack has subsequent parallel smaller cracks. Conclusion can be made that the whole mapped area (Figure 4) is a part of a single failure zone.

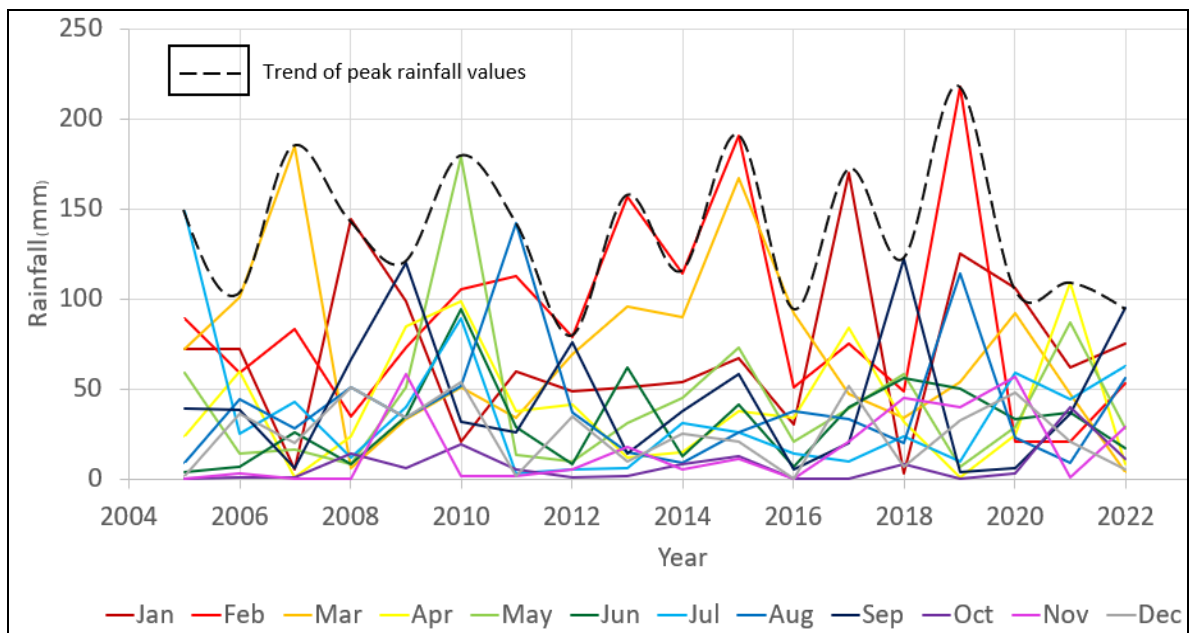
- (3) The available rainfall data (source: IMD) for the period from Jan 2005 to Dec 2022 (Annexure-III) has been analysed. The month-wise rainfall plot for the period is shown in Figure 25. The Annual rainfall (Figure 26) and Monsoonal rainfall ranges from 291.5 mm to 796.5 mm and from 35 mm to 212.9 mm (Figure 27) respectively. In the absence of data on ground deformation and its chronology, correlation of rainfall with ground deformation could not be carried out.

Fig.25: Total monthly rainfall data (mm) of Keylong, Lahaul & Spiti district, HP from 2005-2022.

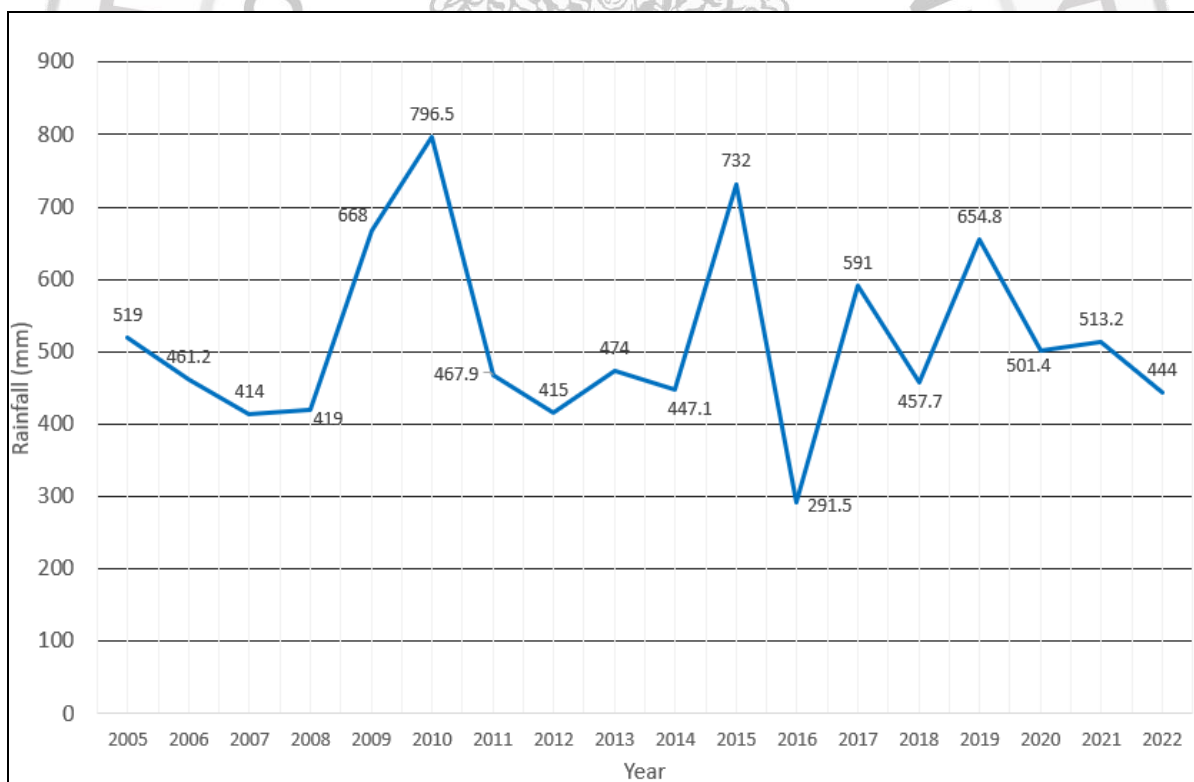
Fig.26: Total annual rainfall data (mm) of Keylong, Lahaul & Spiti district, HP from 2005-2022.
